SITE INSPECTION REPORT

**SEDIMENT REPAIR AT MAPUTO
SUBSTATION**

MOTRACO

NOVEMBER 2022

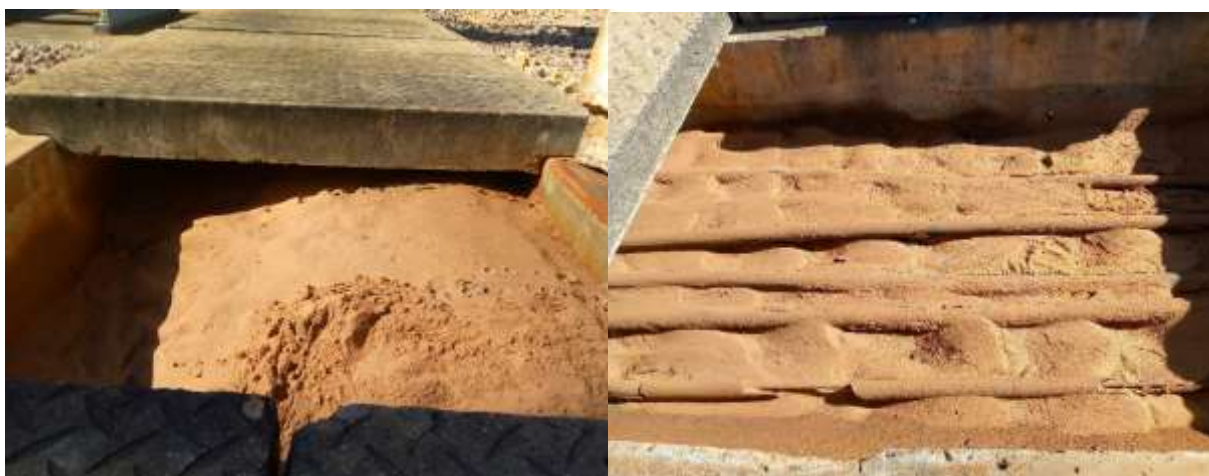
- Sandy material dragged into the cable trenches

In almost all the cable trenches, there is sand that has been dragged into it. Some trenches are practically filled up with dragged sand.

Pictures 1 & 2 – Accumulated material in the cable trench.

At some points the accumulation of sand material is such that it covers the cables.

Regarding the encountered problems, it is recommended to rebuild the cable trenches, which comprises the following works:

- Substitution of the broken kerbs with reinforced precast concrete kerbs as per the attached drawings;
- Cleaning of the trenches, levelling and compaction of the base, and placement of a 100 mm thick layer of river sand on the base;
- Placement of geotextile for filtration along the external perimeter of the trenches;
- Substitution of the broken slab covers.

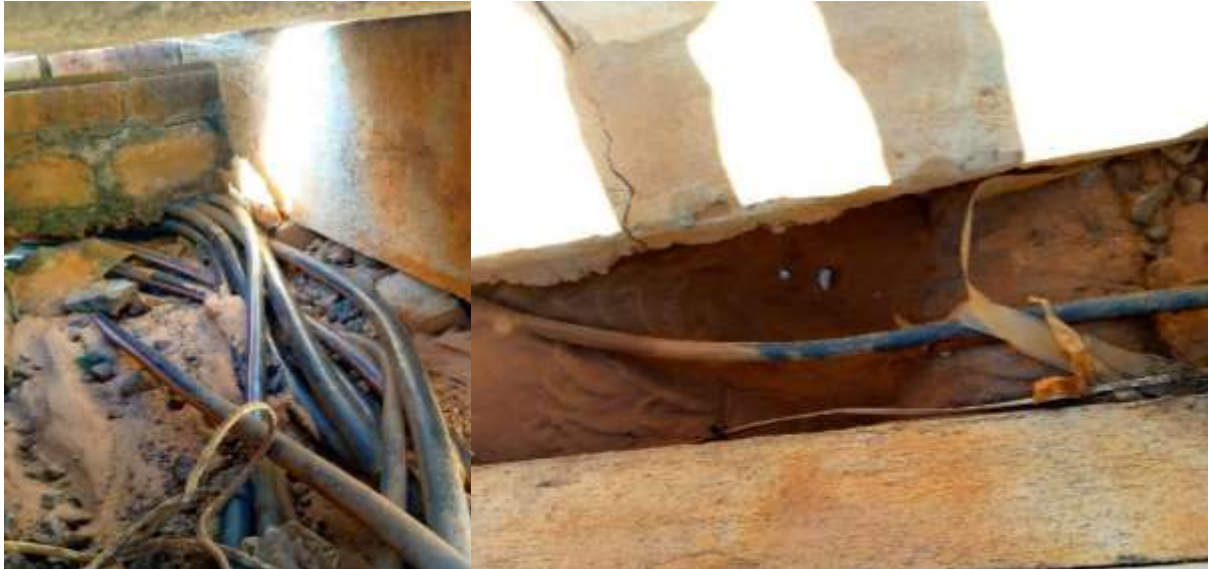
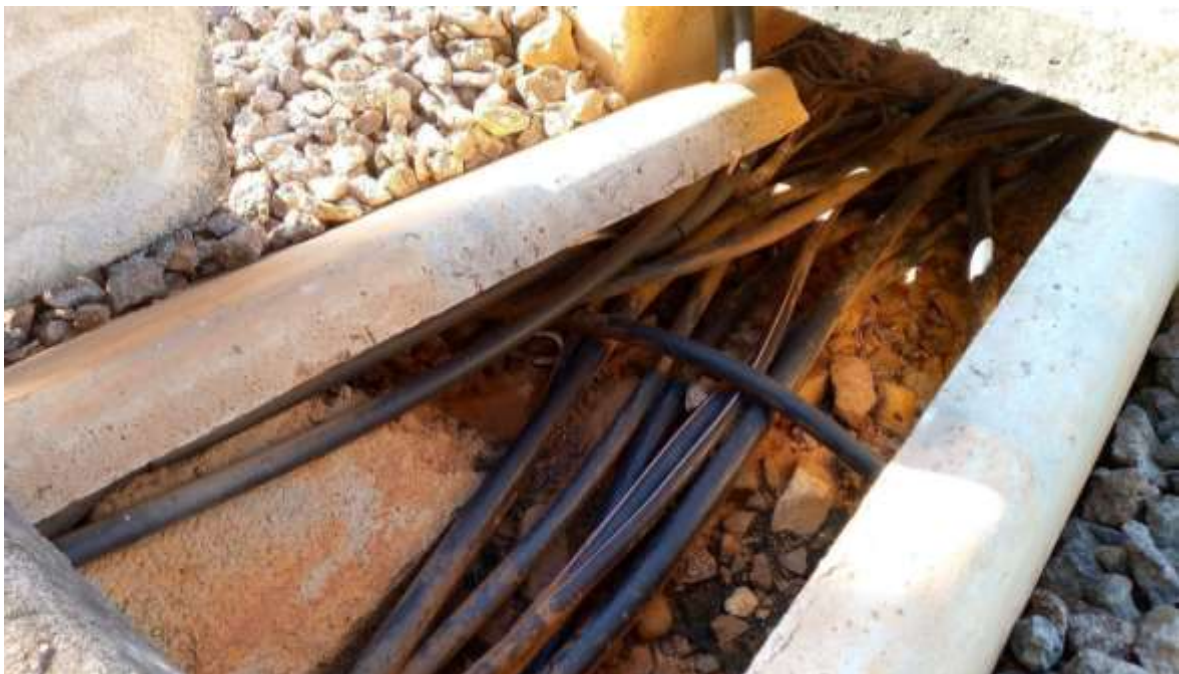
- *Erosion of the kerbs bearing stratum*

The joints between kerbs are unsealed and geotextile is not present, this situation allows water to flow and wash out the fines into the trenches. The highest erosion rates occur near those joints. Sometimes, the erosion of the soil beneath the kerbs (bearing stratum) is high enough to cause collapse of the kerbs.

Pictures 3, 4 & 5 – Soils supporting the kerbs eroded, kerb collapsed (Picture 5).

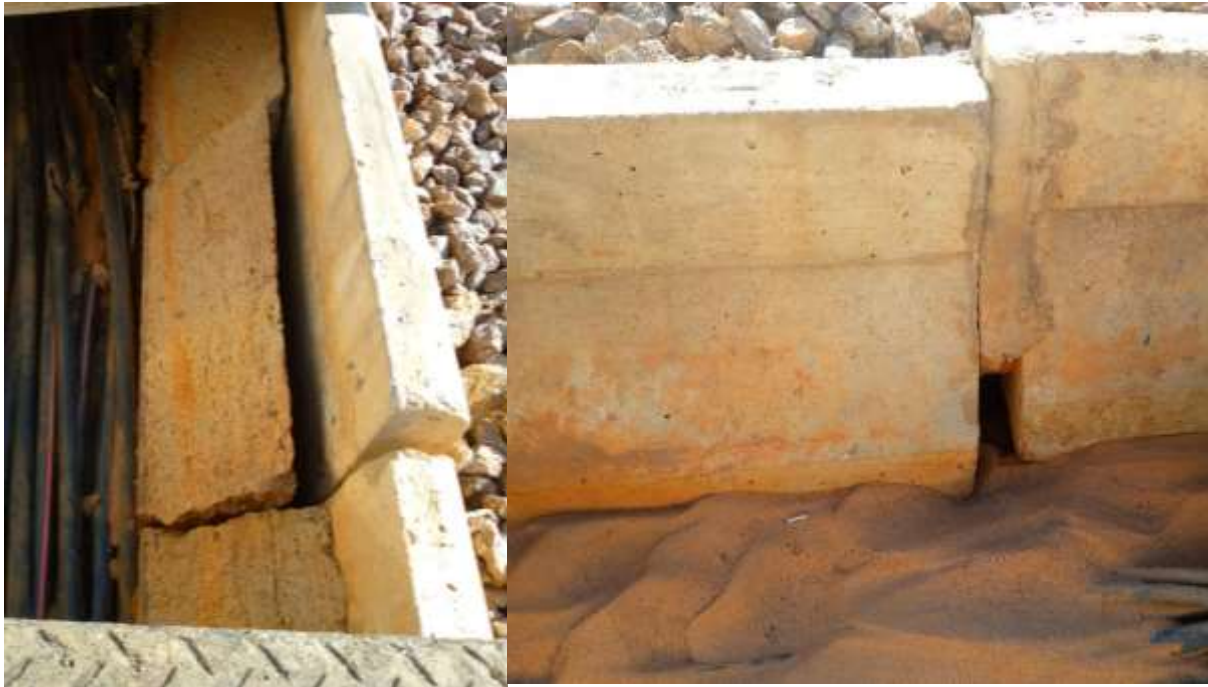
- Differential settlement of the kerbs and settlements along the cable trenches

Since the erosion rate beneath the kerbs is not uniform, differential settlements of kerbs occur near the unsealed joints. In addition, differential settlements occur along the cable trenches.

Pictures 6 & 7 – Differential settlement of the kerbs (400 kV zone).

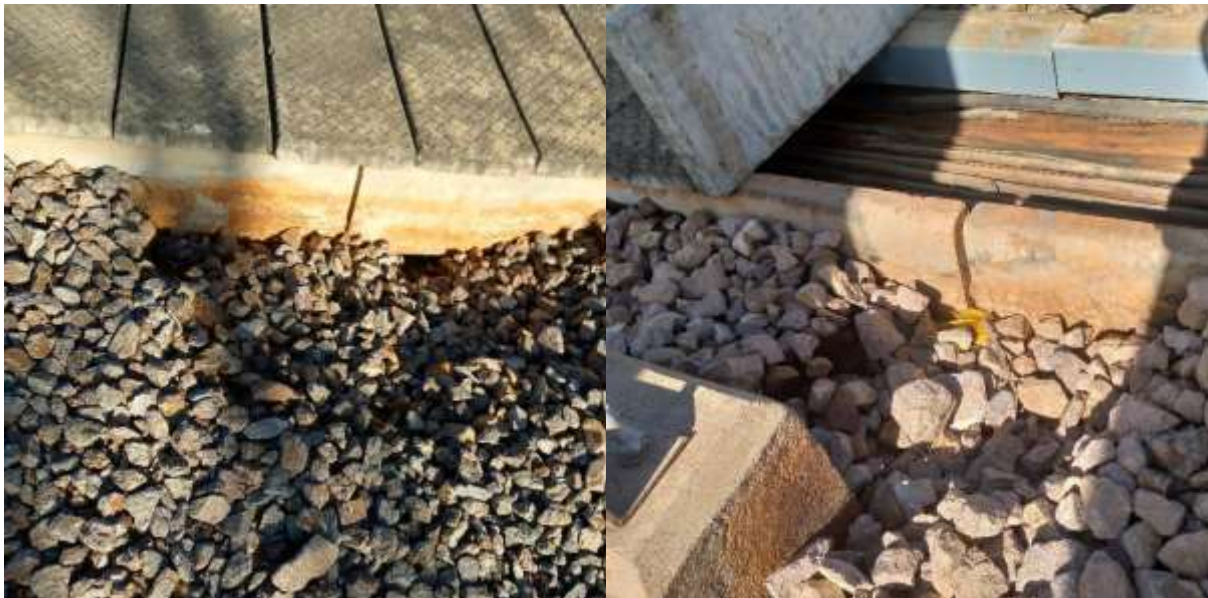
Pictures 8 & 9 – loss of fines and settlements.

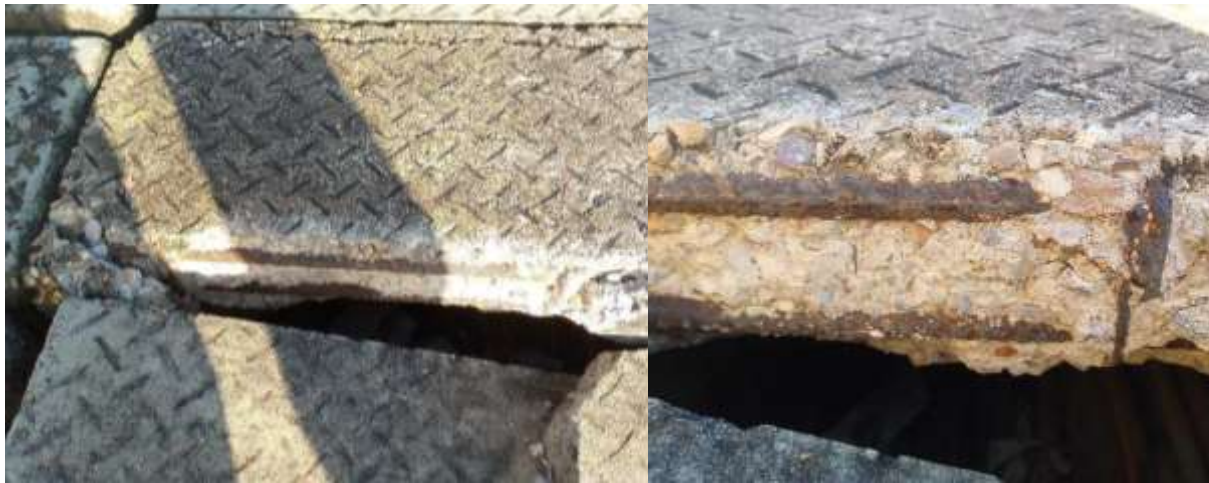
- Broken cable trenches cover slab

Damaged or broken cable trenches covers were found. This occurs due to age and some of them due to lack of proper reinforcement steel.

Pictures 10 & 11 – Damaged cable trenches cover slabs.

Regarding the cable trench ramp crossings for heavy vehicles, the oldest cover slabs were broken due to age (Pictures 10 & 11). Most of the observed cover slabs were broken due to lack of proper reinforcement steel.

Regarding the broken cover slabs of the trenches within the traffic zones of heavy vehicles, the following solution is recommended:

- Substitution of the broken slab covers by the ones with proper reinforcement steel, as shown on Appendix 3.

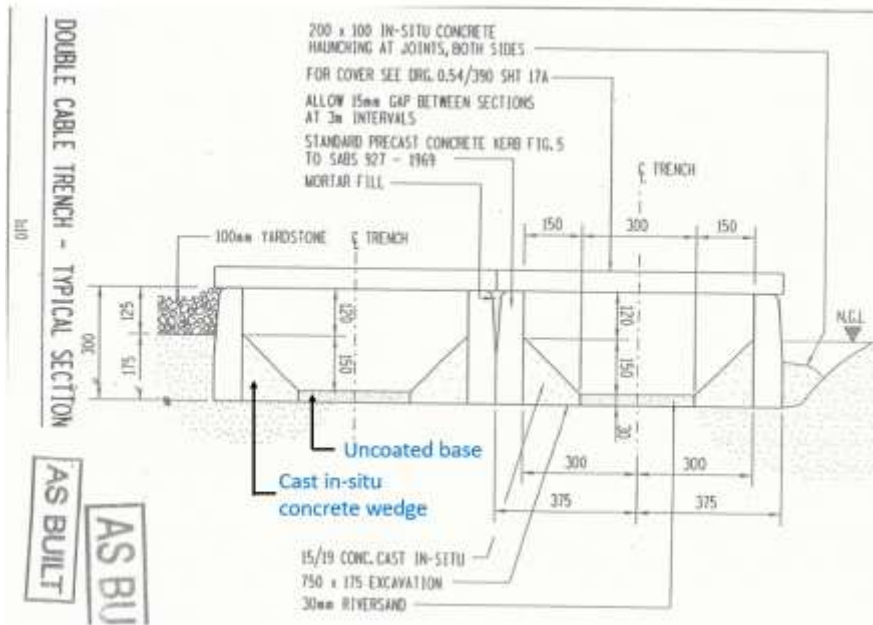
Figure 2 - As-Built drawing of the cable trenches (from MOT/MAP/035, Sheet 16B).

It was also observed that the kerbs that compose the lateral structure of the trenches are made by a standard precast concrete and a cast in-situ concrete wedge, as shown on the As-Built drawing presented on Figure 2.

In these conditions, as there is no solid connection between the precast and the cast in-situ pieces, with variation of temperature and differential settlements those cast in-situ concrete pieces (wedges) are prone to break and separate (Picture13) causing general instability of the trench.

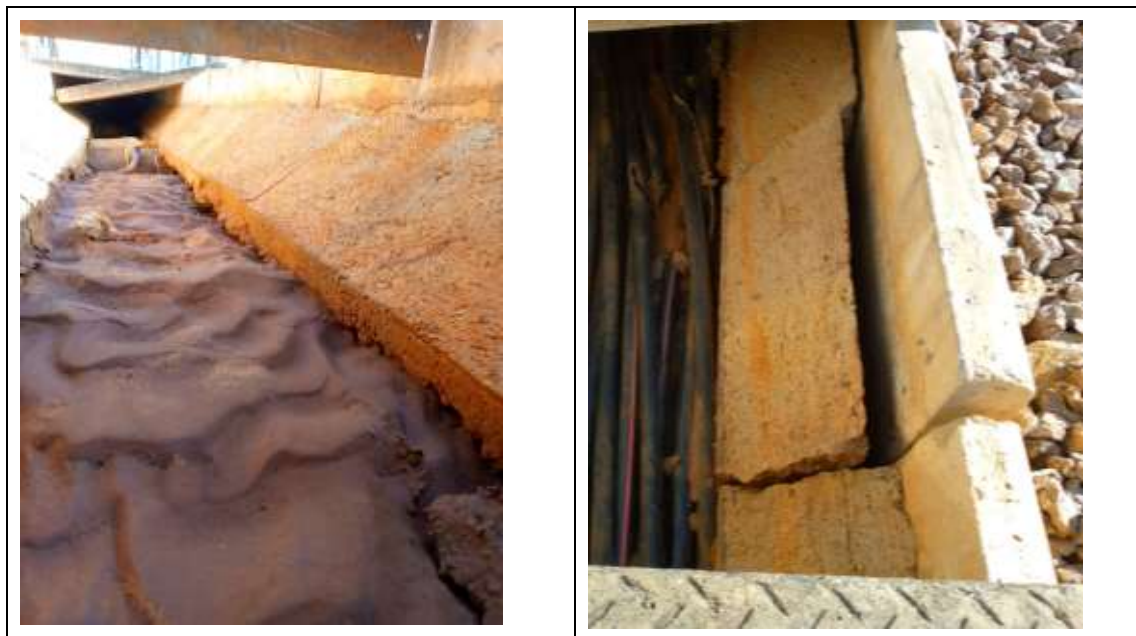
Regarding the existing solution for some cable trenches, it was noticed that the base of the cable trenches is uncoated, so the cables are directly laid on the soil. The storm water that may circulate inside the trenches washes the base material making the cables to sink and be covered with soil (Picture 12).

Pictures 12 & 13 – Cables covered with soil and separation between the cast in-situ concrete wedge and the precast concrete kerb (400 kV zone).

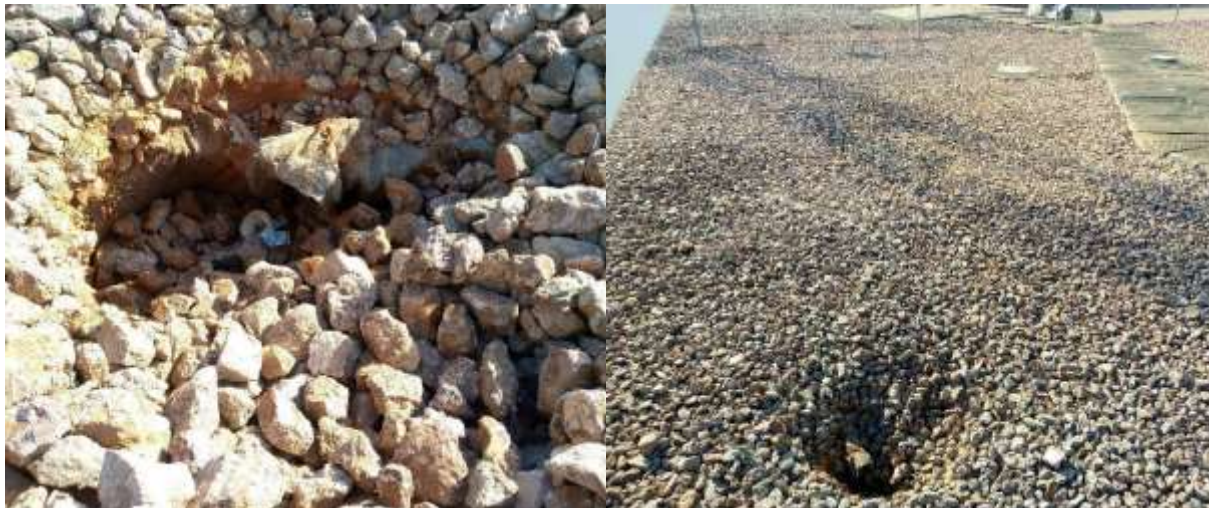
- Localised settlements between manholes

Within the substation yard, localised settlements between manholes can be found. This may be due to damaged drainage pipes in the manhole alignments.

Pictures 14 & 15 – Localised settlement between manholes, 400 kV zone.

- Verify if the geotextile are well placed
- Verify the occurrence of damaged pipes
- Removal and replacement of all damaged drainage pipes including geotextile, as per the construction drawings.

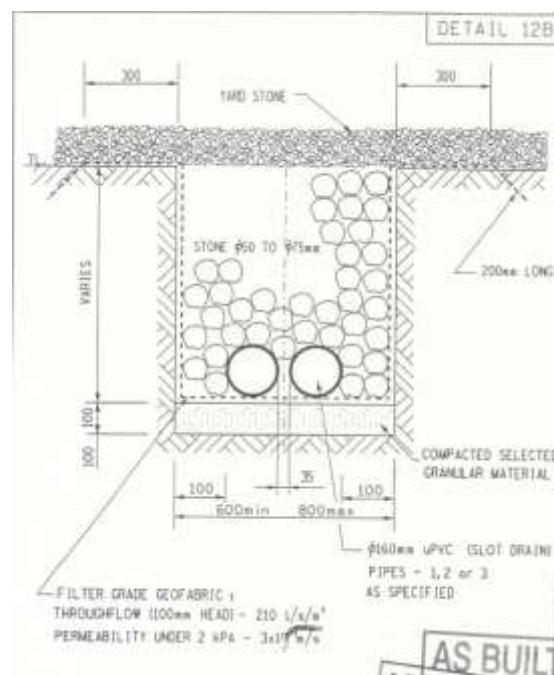
Figure 3 - As-Built drawing of the sub-soil drain (from MOT/MAP/035, Sheet 12B).

On a previous site inspection done in 2015 on some storm water drainage system and inspection boxes, it was found that the slotted pipes that make the connection between inspection boxes were not involved in geotextile.

As per the As-Built drawings, apparently a trench was excavated to insert the tubes, and then geotextile was placed on the walls of the trench and subsequently backfilled with rock fill (Figure 3).

We suspect that the backfill material of the trench was made with sand material and a superficial layer of rock fill material, instead of only rock fill. This needs to be confirmed during reparation works.

It may be also the case of the connection between the geotextile blankets not being properly overlaid, allowing soil material to be washed when the storm waters flow in the direction of the perforated tubes.

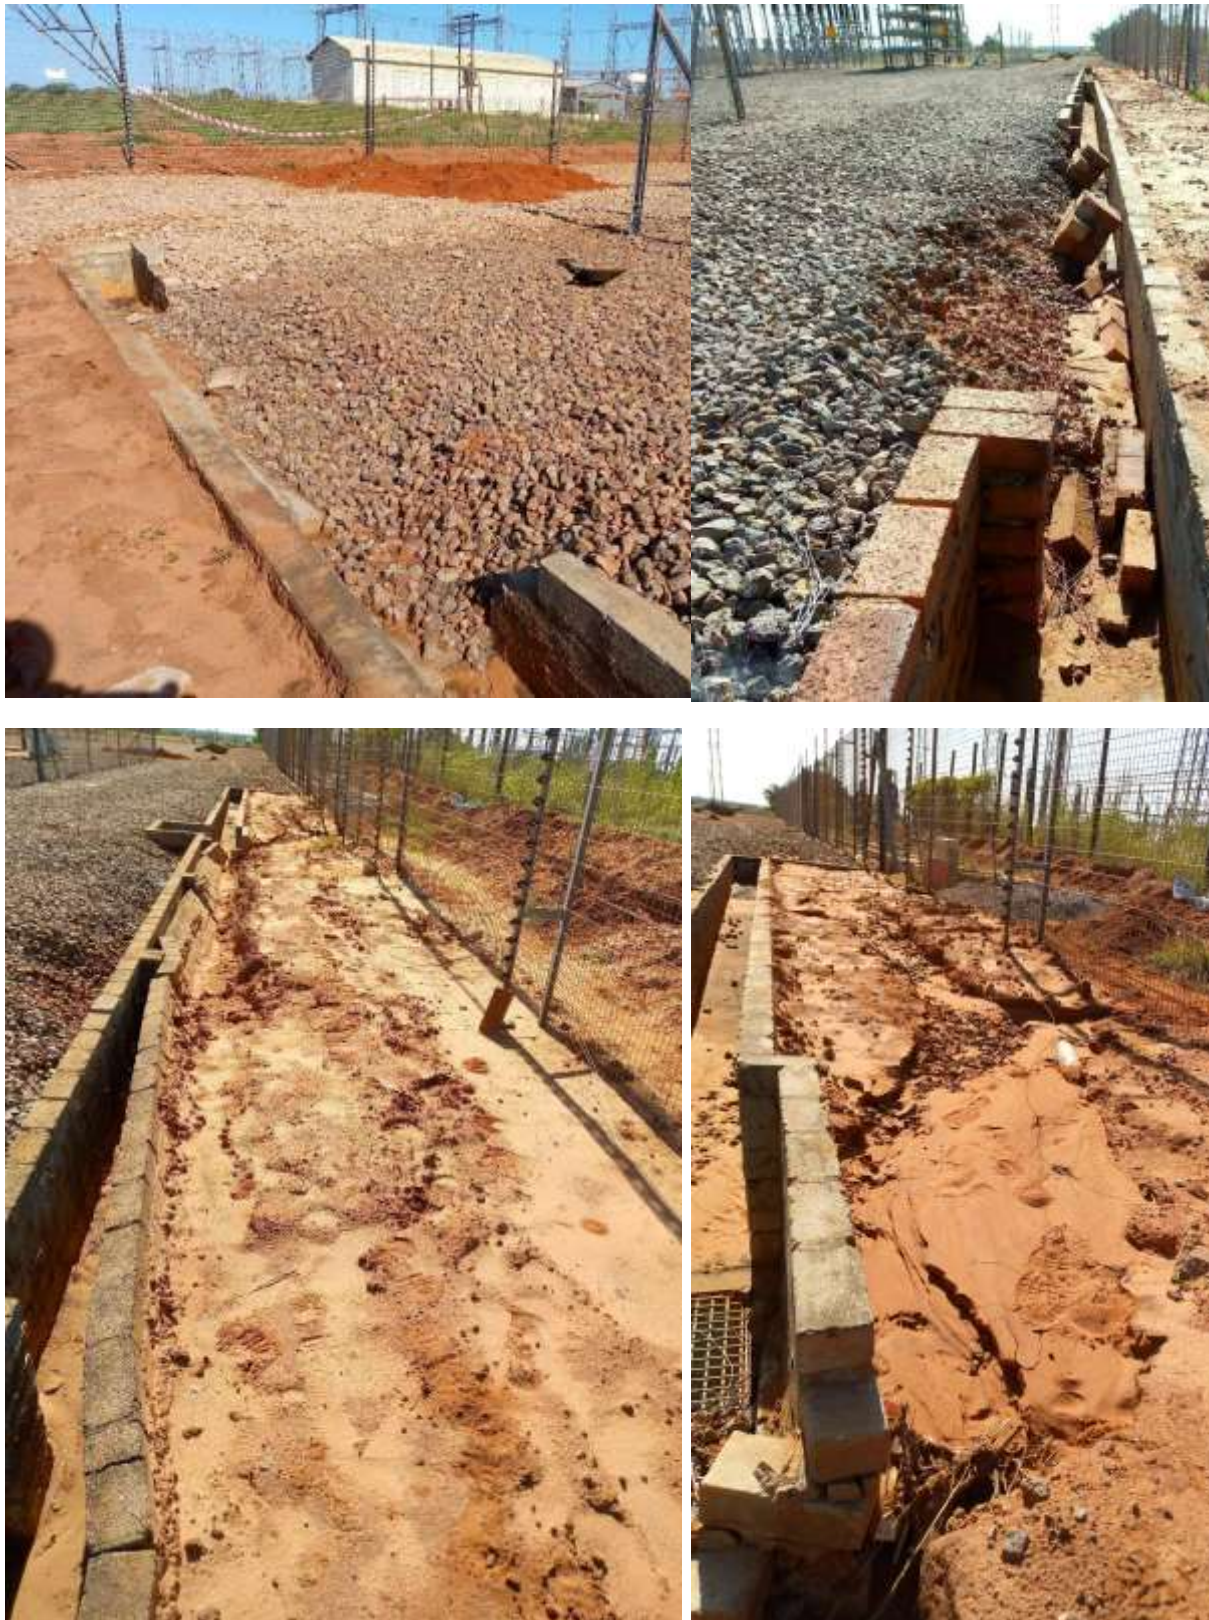
- Intrusion of fines;
- Collapse of the masonry walls due to lateral earth pressure.

Pictures 16, 17, 18 & 19 – Collapsed walls, intrusion of fines (275 kV Zone).

In order to avoid the collapse of the drainage ditches walls and the intrusion of fines, the following solutions are proposed:

- Rebuilding of the collapsed drainage ditches with braced walls;
- Building of bracings where no collapse of the walls occurred yet;
- Placement of geotextile for filtration between the soil and the backside of the masonry walls.
