SITE INSPECTION REPORT

**SEDIMENT REPAIR AT MAPUTO
SUBSTATION**

MOTRACO

NOVEMBER 2022

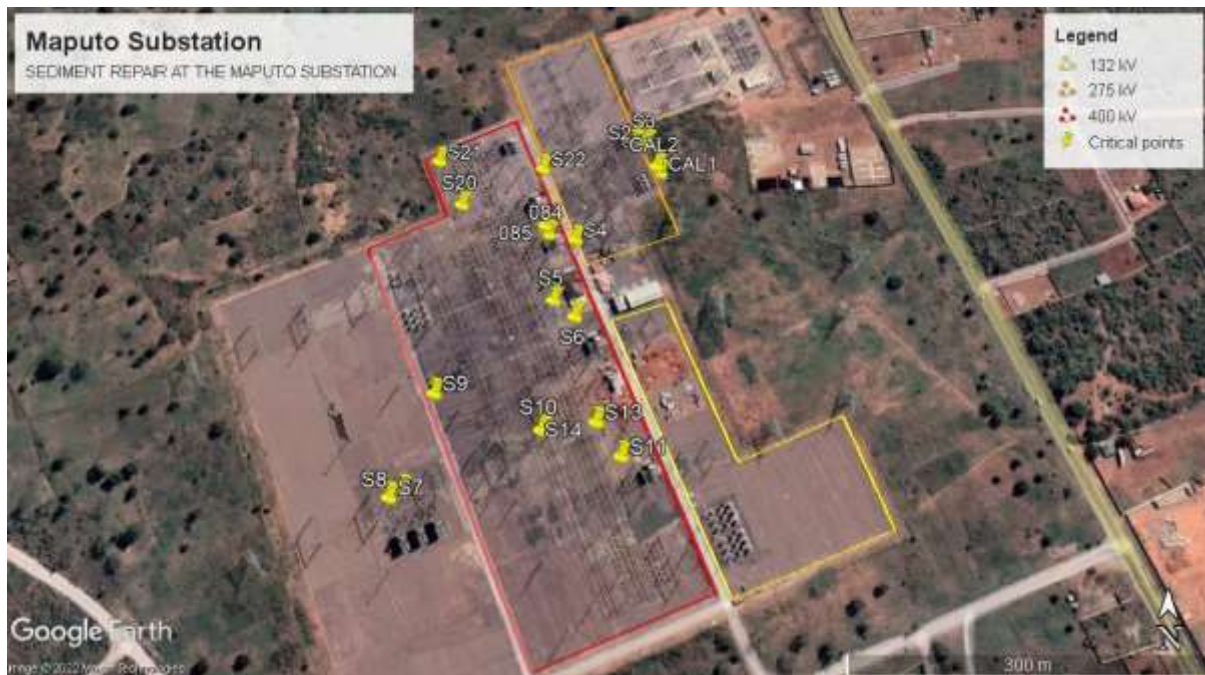
Figure 1 - Zoning of the Maputo Substation.

In the substation, three (03) distinct zones can be identified, namely: 132 kV, 275 kV and 400 kV, as illustrated in Figure 1 and Appendix 1. In the mentioned zones, it was possible to generally identify the following:

- Loss of fine soils and settlement around cable trenches;
- Differential settlement of kerbs and broken covers of cable trenches;
- Collapse of drainage ditches walls;
- Localised settlements between manholes within the substation yard.
